# **Retesting of Lead and Nickel Levels in Rainwater Tanks at Esperance**

**February, 2008**

**THE UNIVERSITY OF  
WESTERN AUSTRALIA**

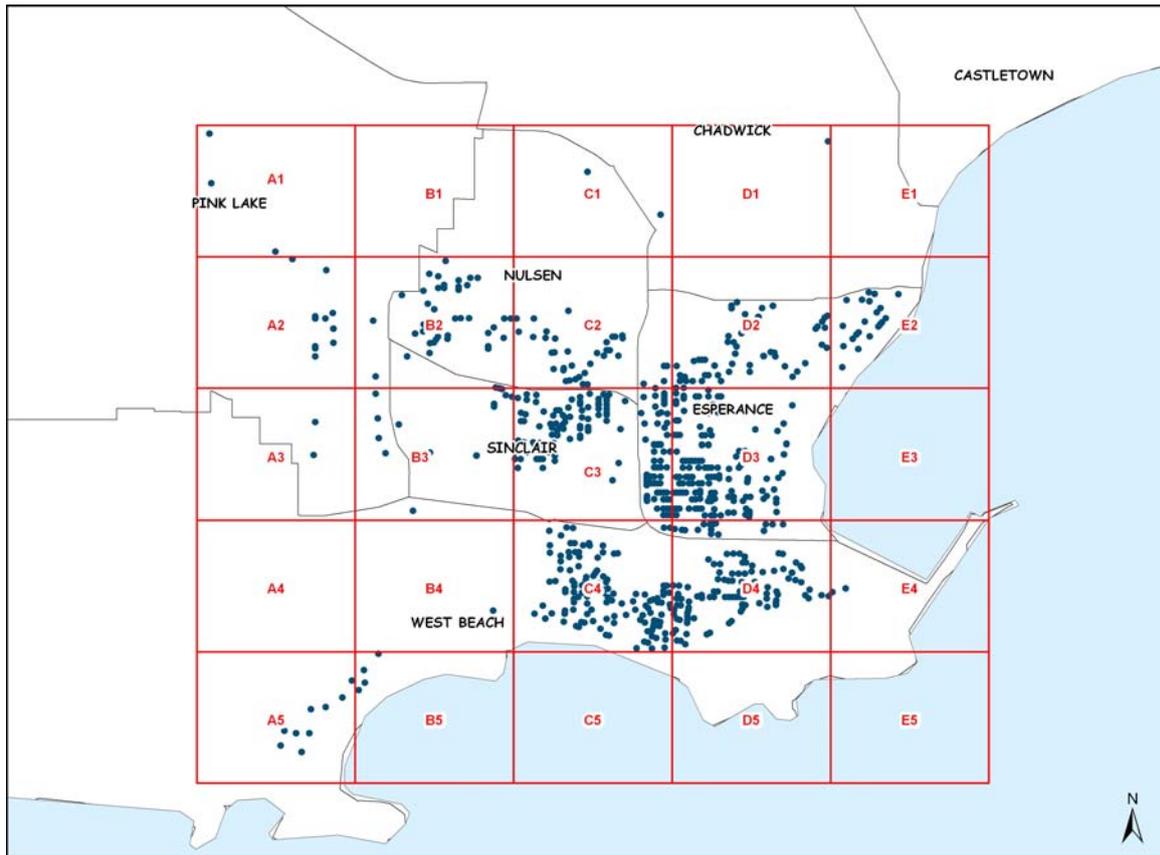
**Figure 1 Location of rainwater tanks that were eligible for re-sampling, Esperance October 2007**

The study region was stratified by a 1 km square grid over the study area, resulting in 25 cells (Figure 1). A sample of tanks was randomly selected from each grid. The number from each grid varied proportional to the number of rainwater tanks initially tested in that grid. Also approximately 100 tanks were to be sampled from 423 tanks that had been cleaned by the EspPA.

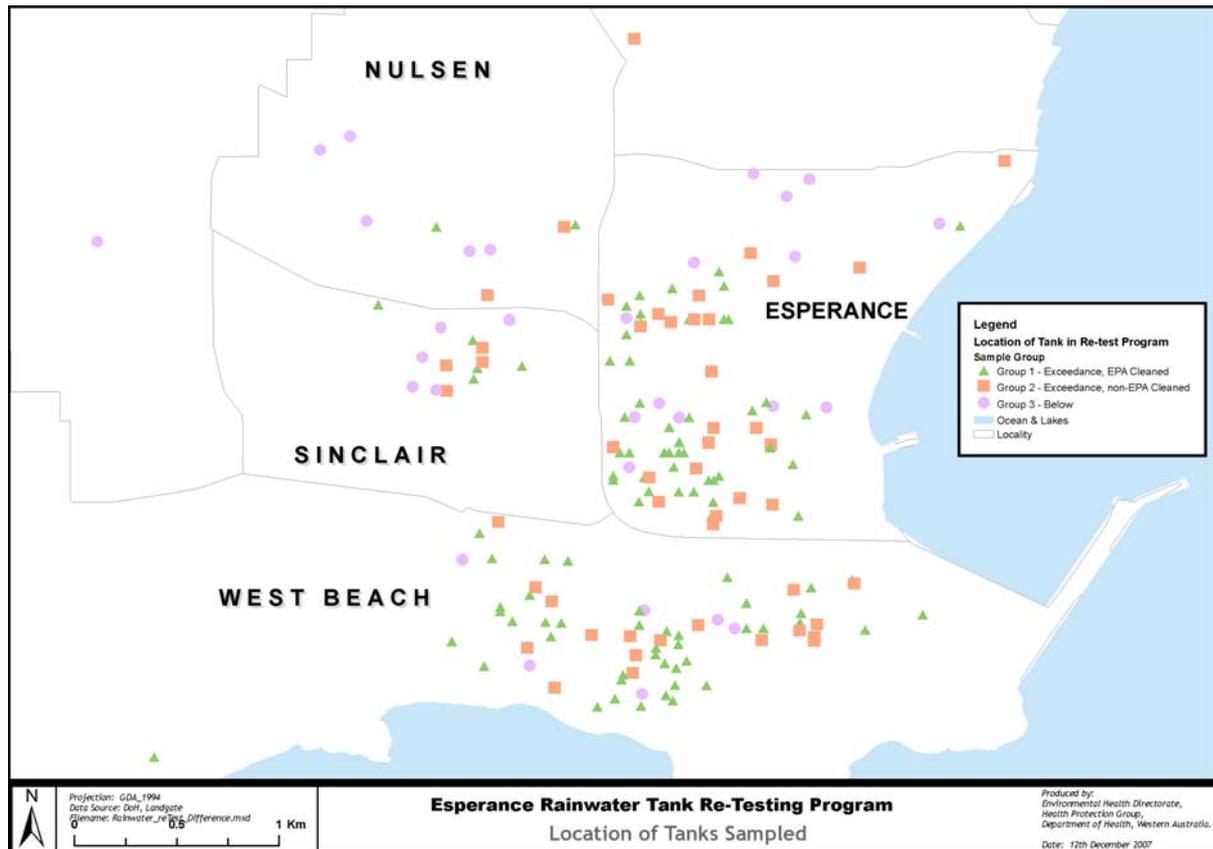
**Figure 2 Location of rainwater tanks for retesting by Group, Esperance 2007**

Figure 2 shows the location of tanks in Group 1, Group 2 and Group 3 within the study area.

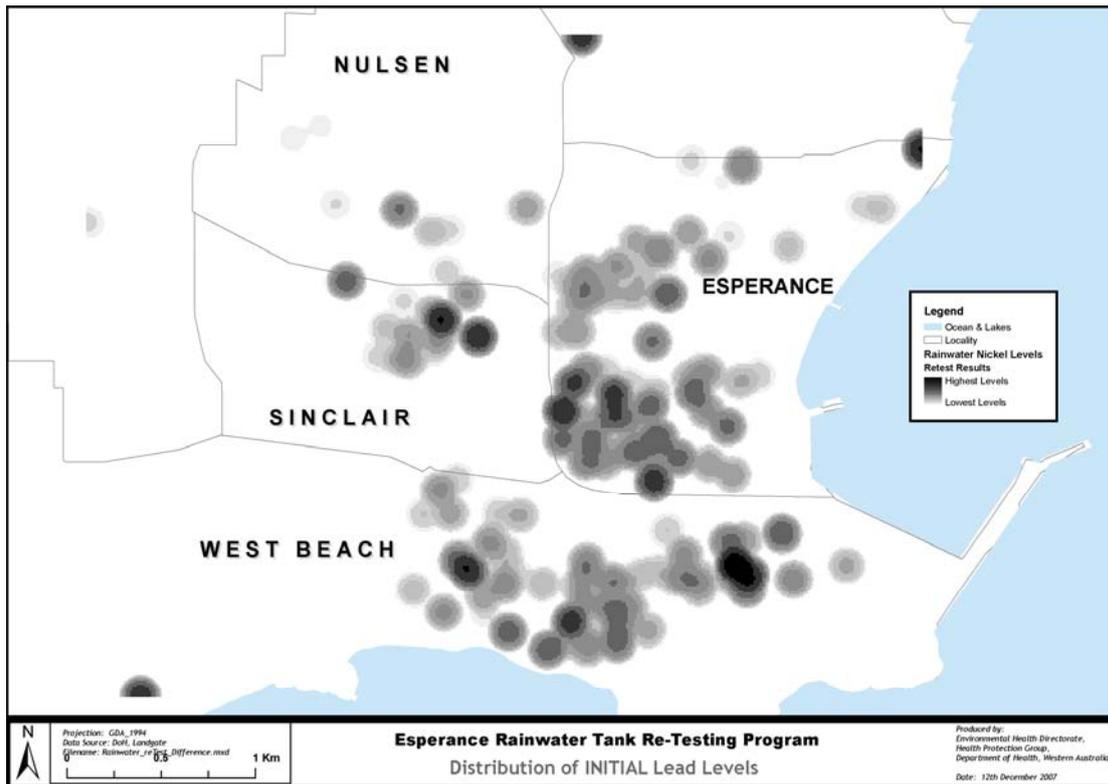
**Figure 3 Spatial Distribution of Lead Levels in Rainwater Tanks at Baseline, Esperance March- June 2007**

Figures 3 and 4, provided by the Department of Health, present smoothed maps of lead concentrations in the study area at baseline and follow-up. They depict a visual summary of the spatial distribution of lead levels. Figures 5 and 6, also provided by the Department of Health, are smoothed maps of nickel concentrations in the study area as at baseline and follow-up.

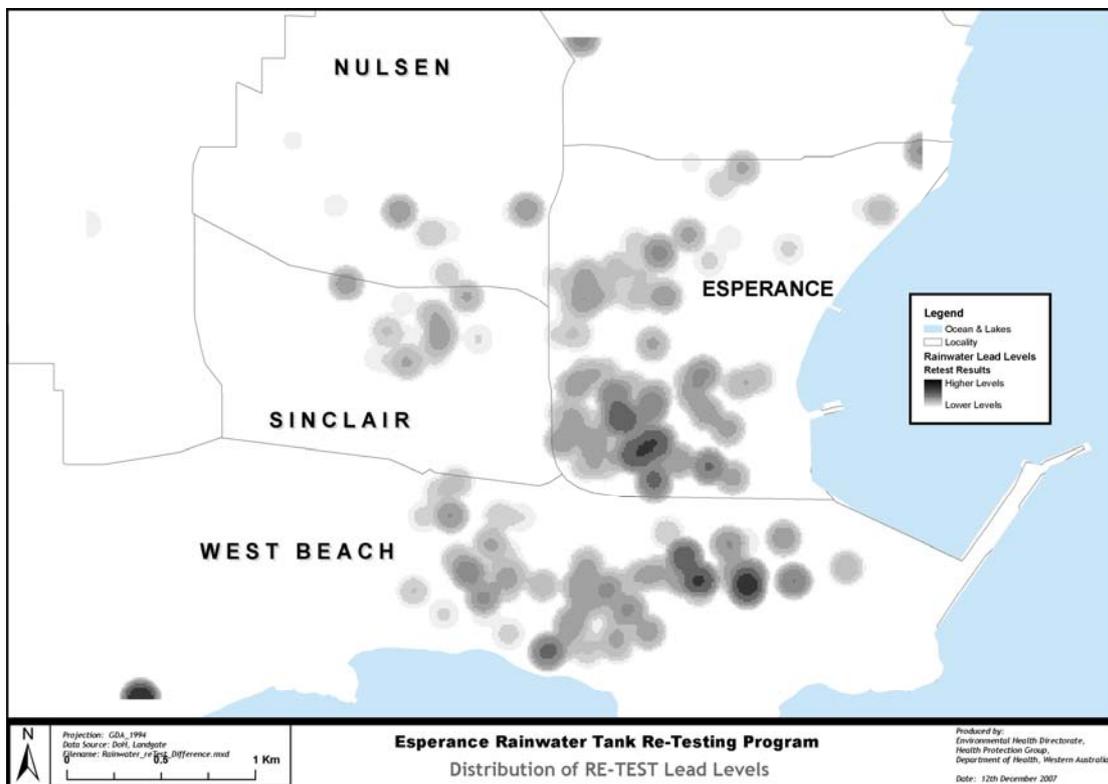
**Figure 4 Spatial Distribution of Lead Levels in Rainwater Tanks at Follow-up, Esperance, October 2007**

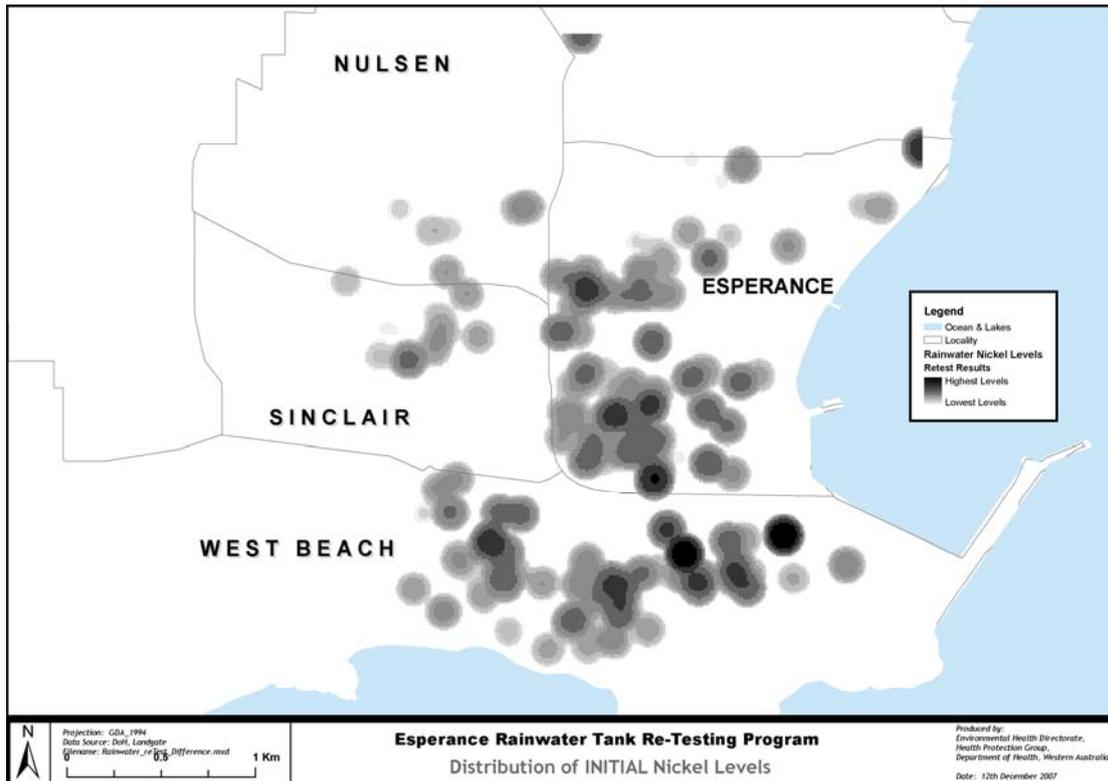
**Figure 5 Spatial Distribution of Nickel Levels in Rainwater Tanks at Baseline, Esperance March- June, 2007**

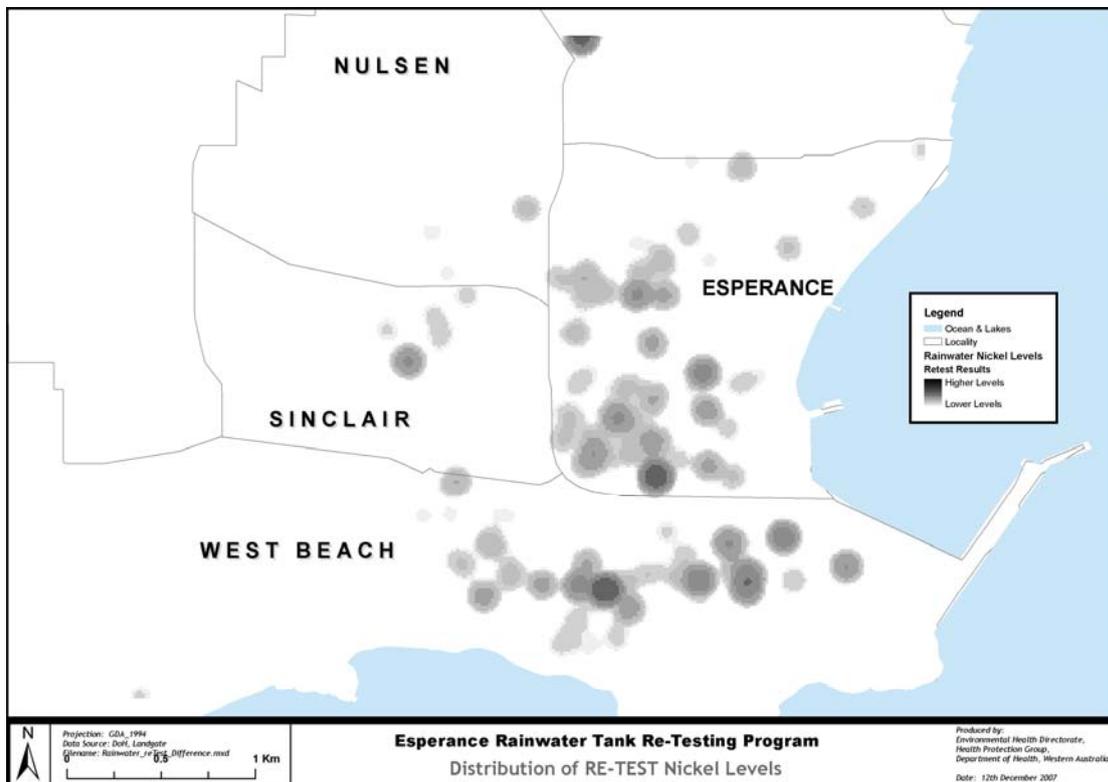
**Figure 6 Spatial Distribution of Nickel Levels in Rainwater Tanks at Follow-up, Esperance, October 2007**

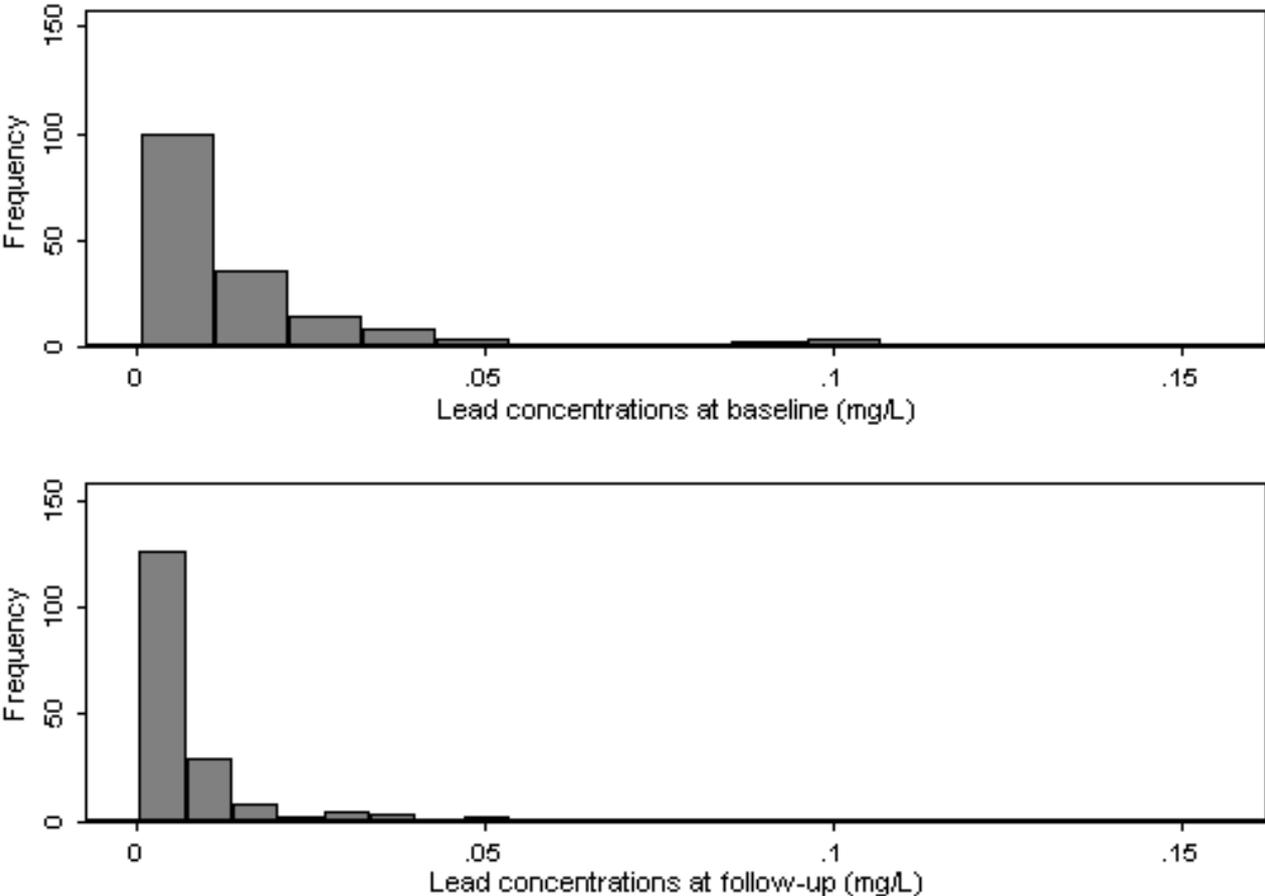
**Figure 7 Distribution of lead concentrations at baseline and follow-up**

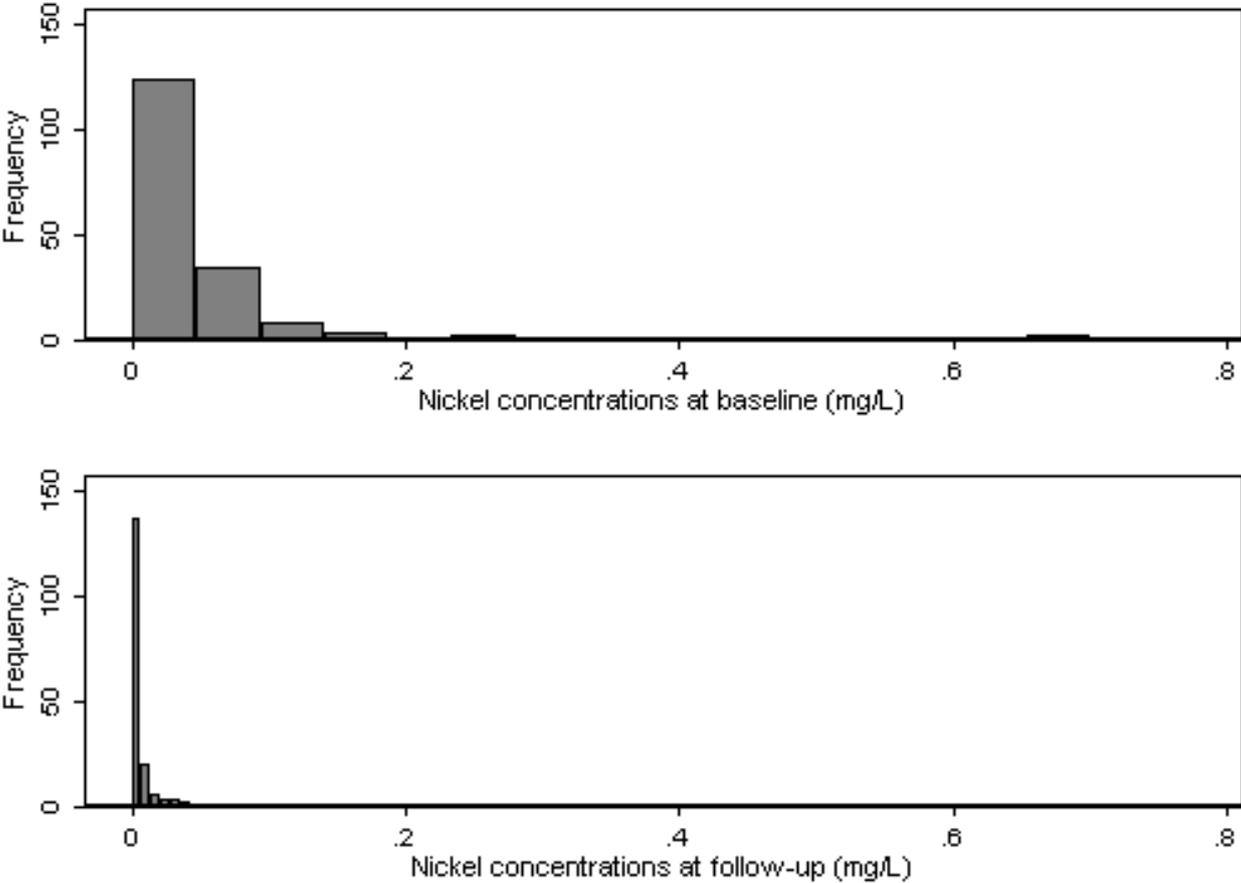
**Figure 8 Distribution of nickel concentrations at baseline**
